Present State Of The EU-Cavity Tests At DELTA

Robert Heine, Thomas Weis & Group

Universität Dortmund
Institut für Beschleunigerphysik und Synchrotronstrahlung
Maria-Goeppert-Mayer Straße 2
D-44221 Dortmund

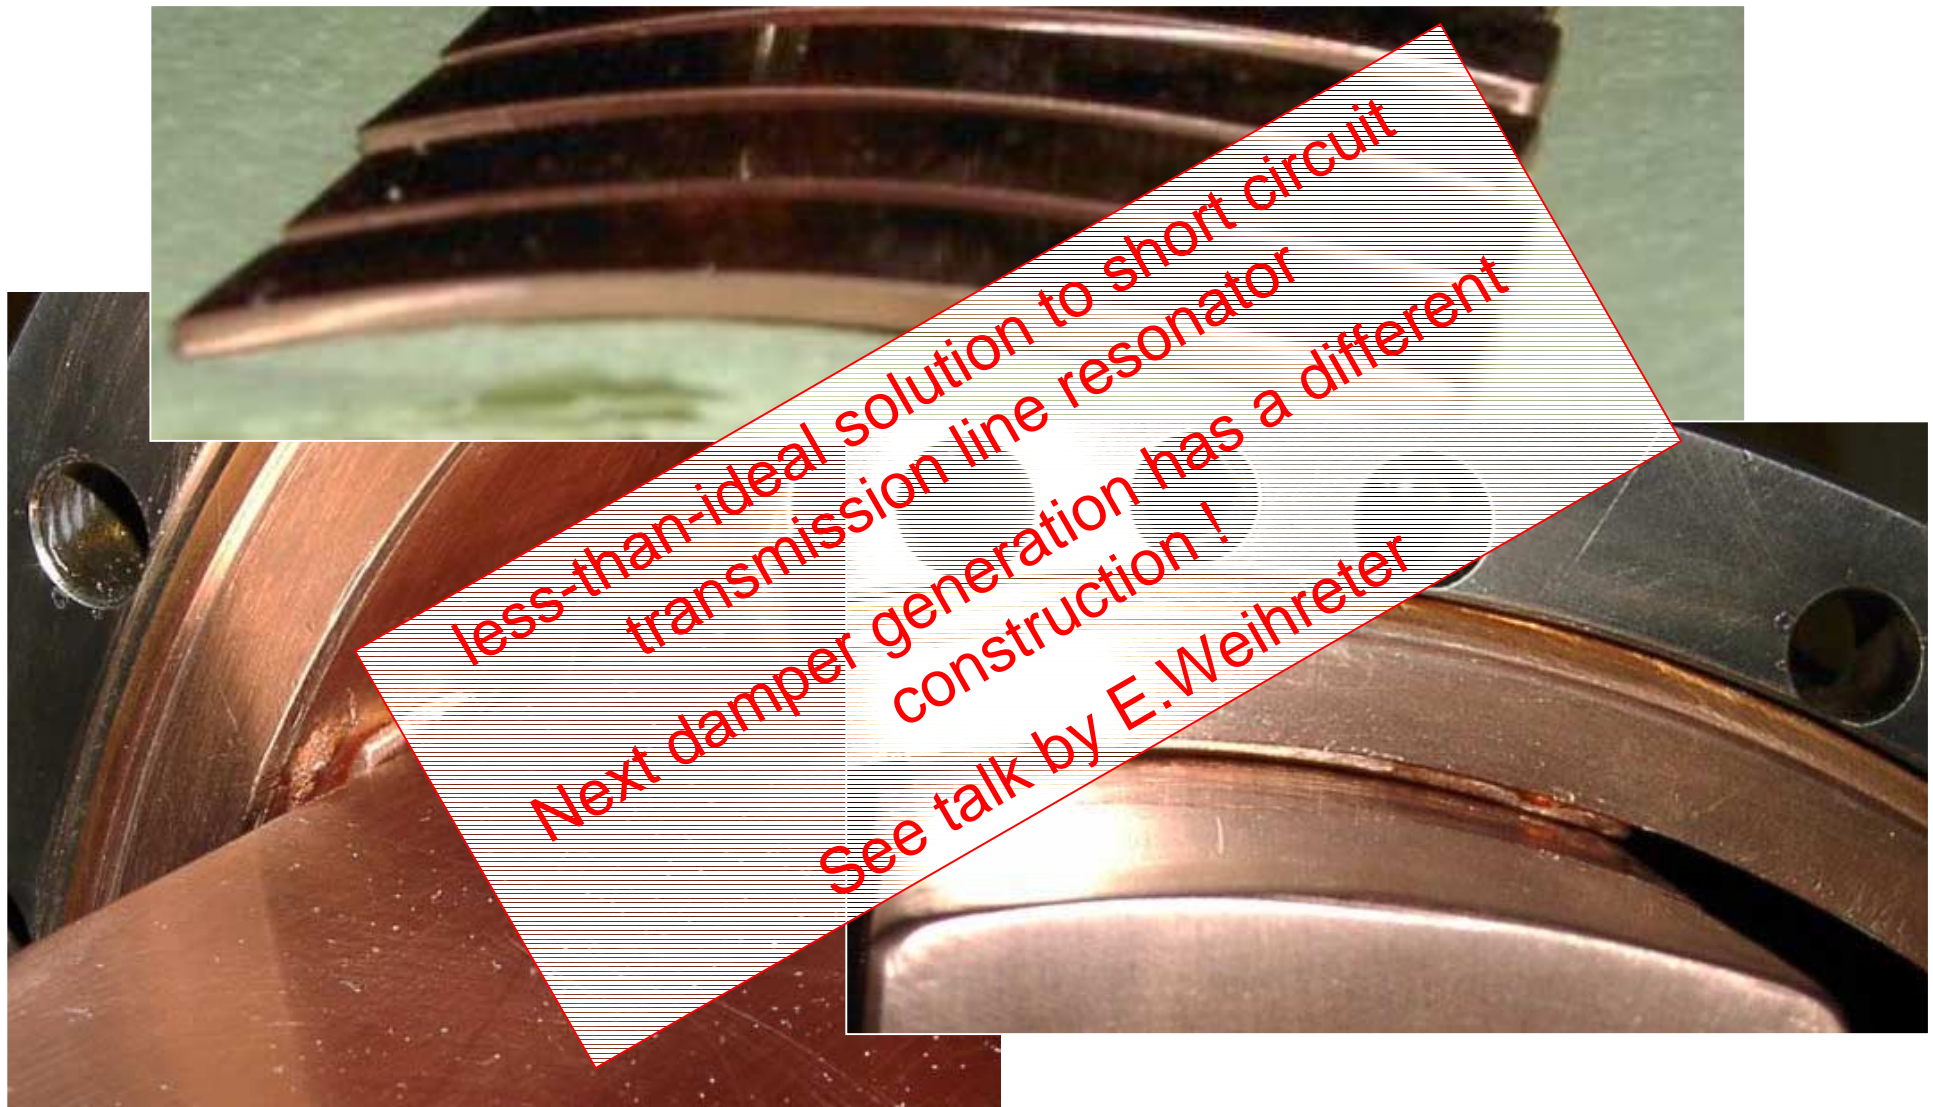
Spacer

- Jan.7th: Dampers back in house
- Jan.10th: Mount of dampers and heating of cavity until Jan.17th
- since Jan.19th: Check with low level RF (mW and 20 W) gave inconsistent results for coupling factor and Q_0 depending on mechanical stress (vacuum) and temperature.
- Insufficient electrical contact between spacer and damper wall turned out to be responsible for this behaviour.
- May 11th: Replacement of spacers in Damper T2, back to original results ($Q_0 \approx 24000$, $\beta = 1.7$)
problem fixed!

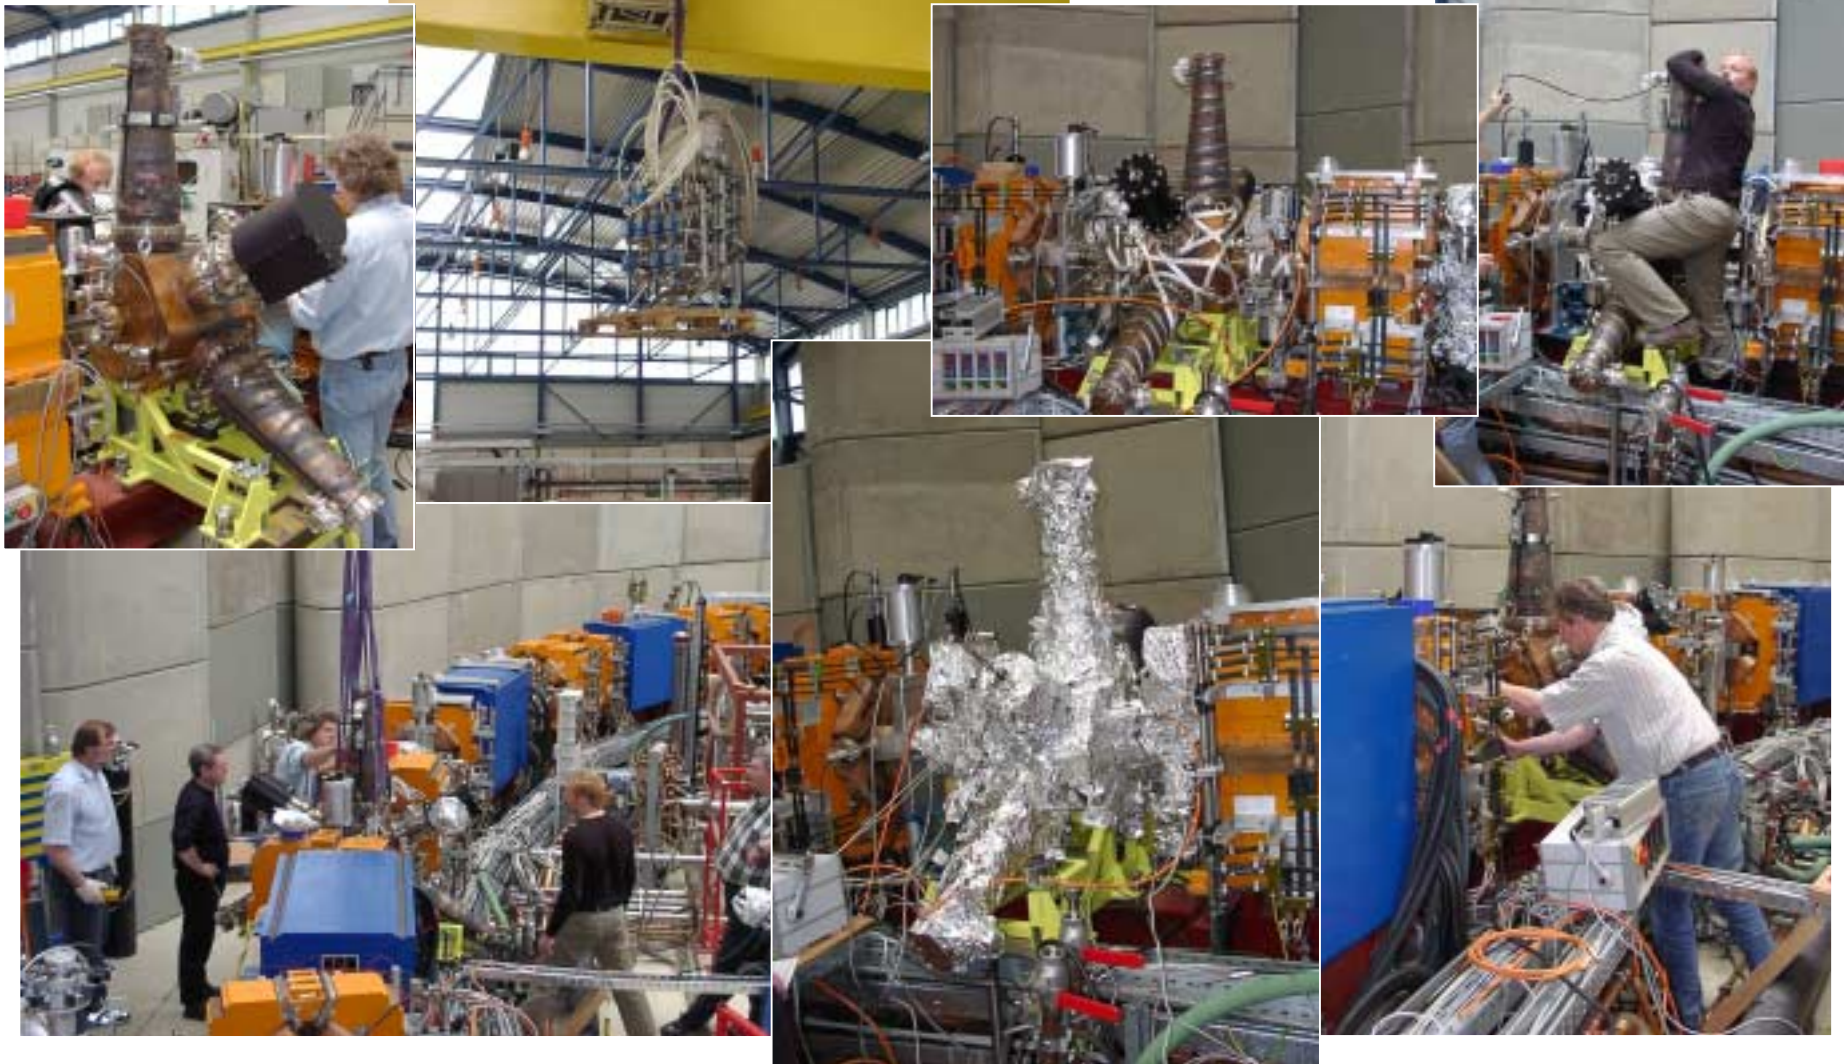
What It Means To Exchange A Cavity!

- Insertion: Jun. 28th - Jul 5th.
- Jul.5th: RF conditioning started, 10kW CW reached that day.
- Jul.6th: Threshold at 14kW CW, switch to pulse conditioning. Frequent vacuum bursts (every 20 min), hint for an association to plunger movements.
- Jul.7th: 20kW@95% duty cycle, frequency wobbling to force plunger movement.
- Jul.25th: 20kW CW, number of vacuum bursts reduced.
- Aug.1st: Start of beam operations, $I=140$ mA were reached on friday
- Aug. 15-19 & Aug. 22-26: user dedicated shifts

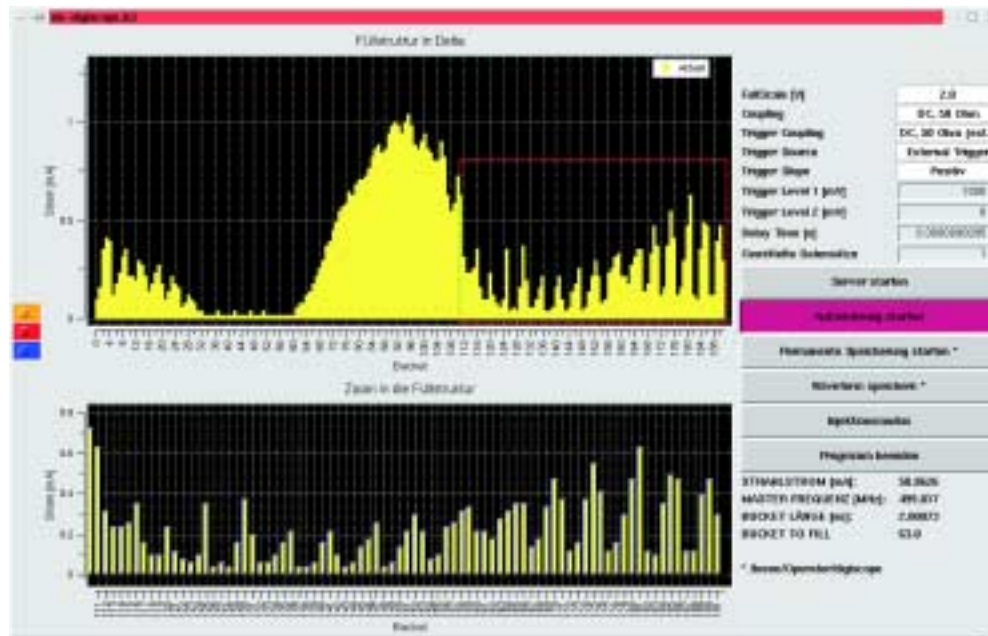
Post Mortem Analysis Of Beam Losses

- For filling structure analysis an oscillograph PCI Card samples the time signal of the beam.
- CBM losses produce a certain filling structure (see left figure)
- FFT of this signal contains information on the CBM that was responsible for beam loss (see below)

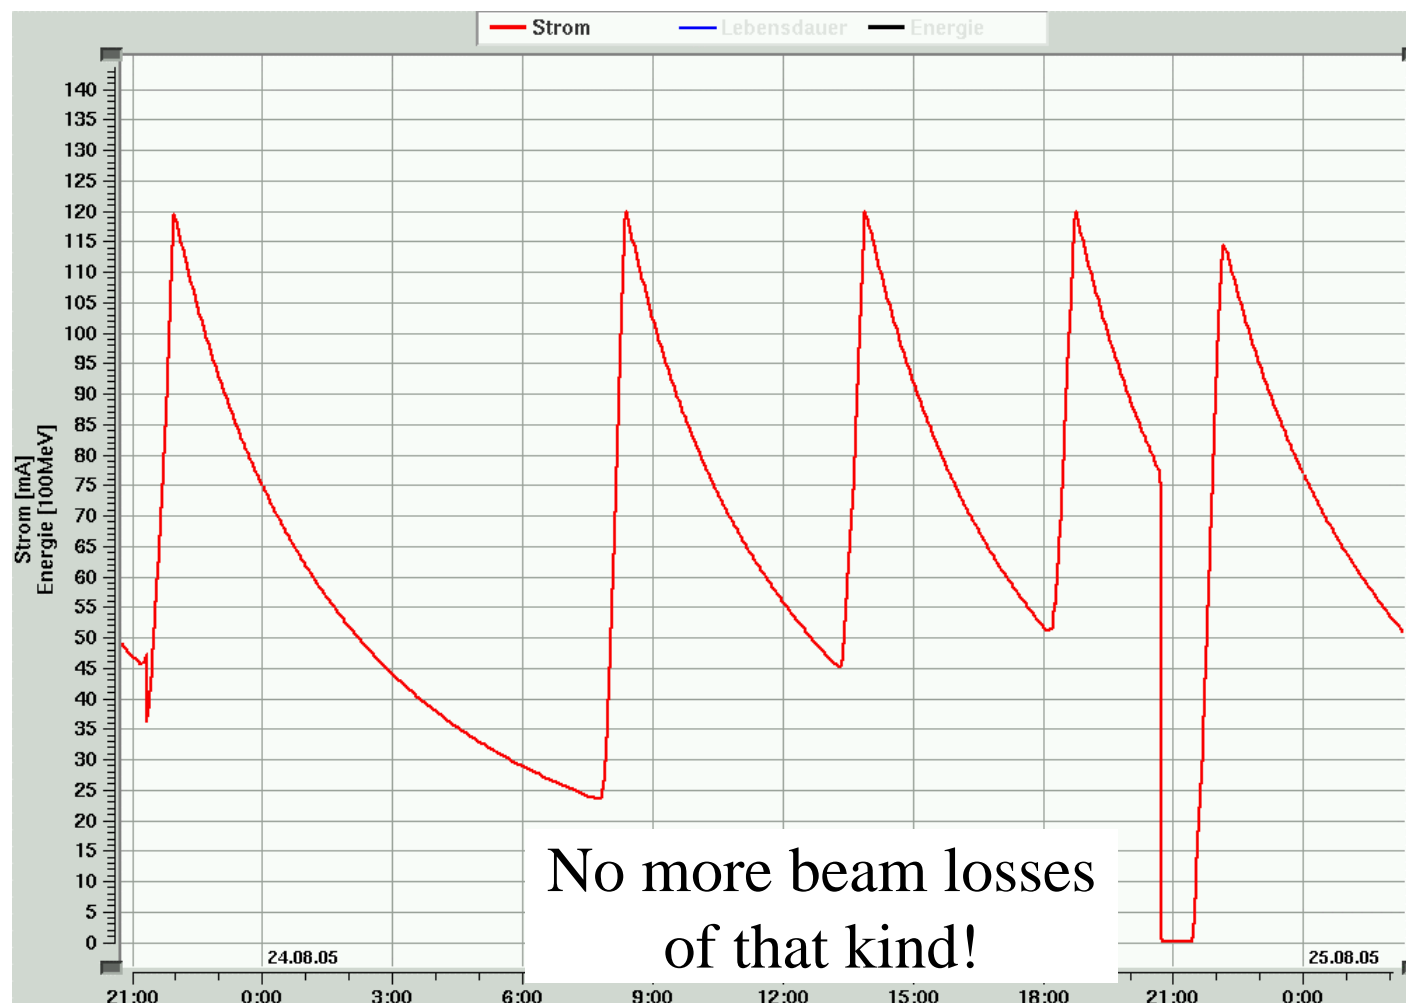
A User-Dedicated Week With The HOM-Damped Cavity

No more beam losses
of that kind!
